NOTE

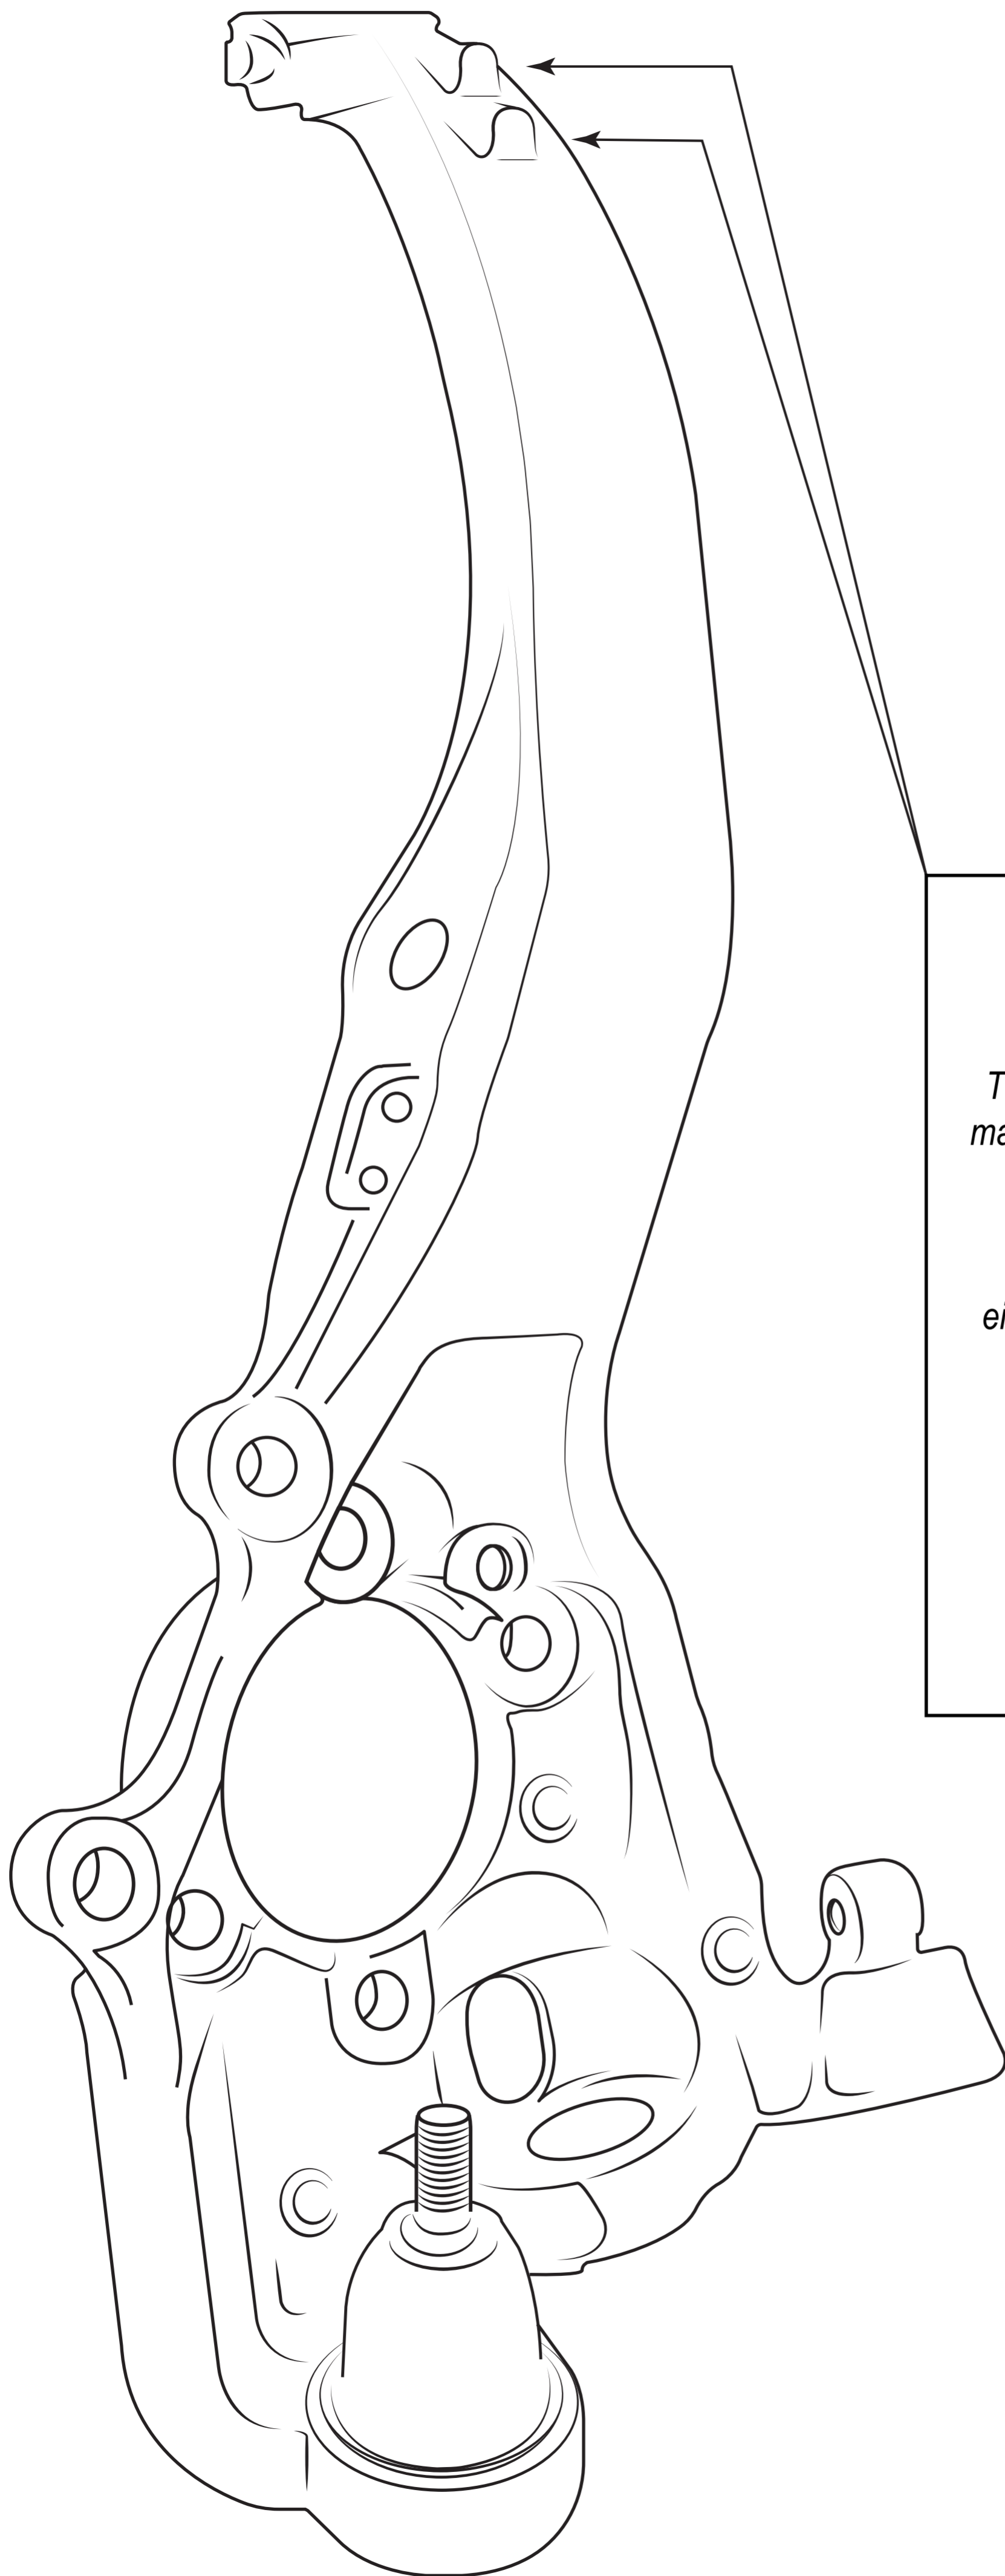
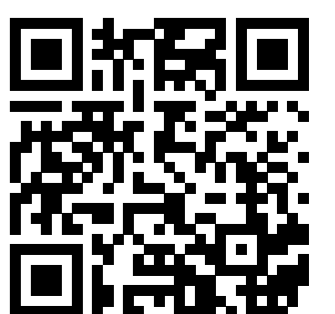
The OEM knuckle has two castings marks that may interfere with the upper camber arms during suspension operation.

This is most commonly seen when running either a low ride height, having soft suspension or when the suspension is compressed and on or near full steering lock.

We do recommend, regardless, grinding the casting marks flush to avoid any possible contact being made.
